MISCELLANEOUS PAPER GL-91-6

# GEOPHYSICAL SURVEYS FOR LOCATION OF A SUSPECTED ABANDONED MINE OPENING: GRAYS LANDING SITE

March 1991

Final Report

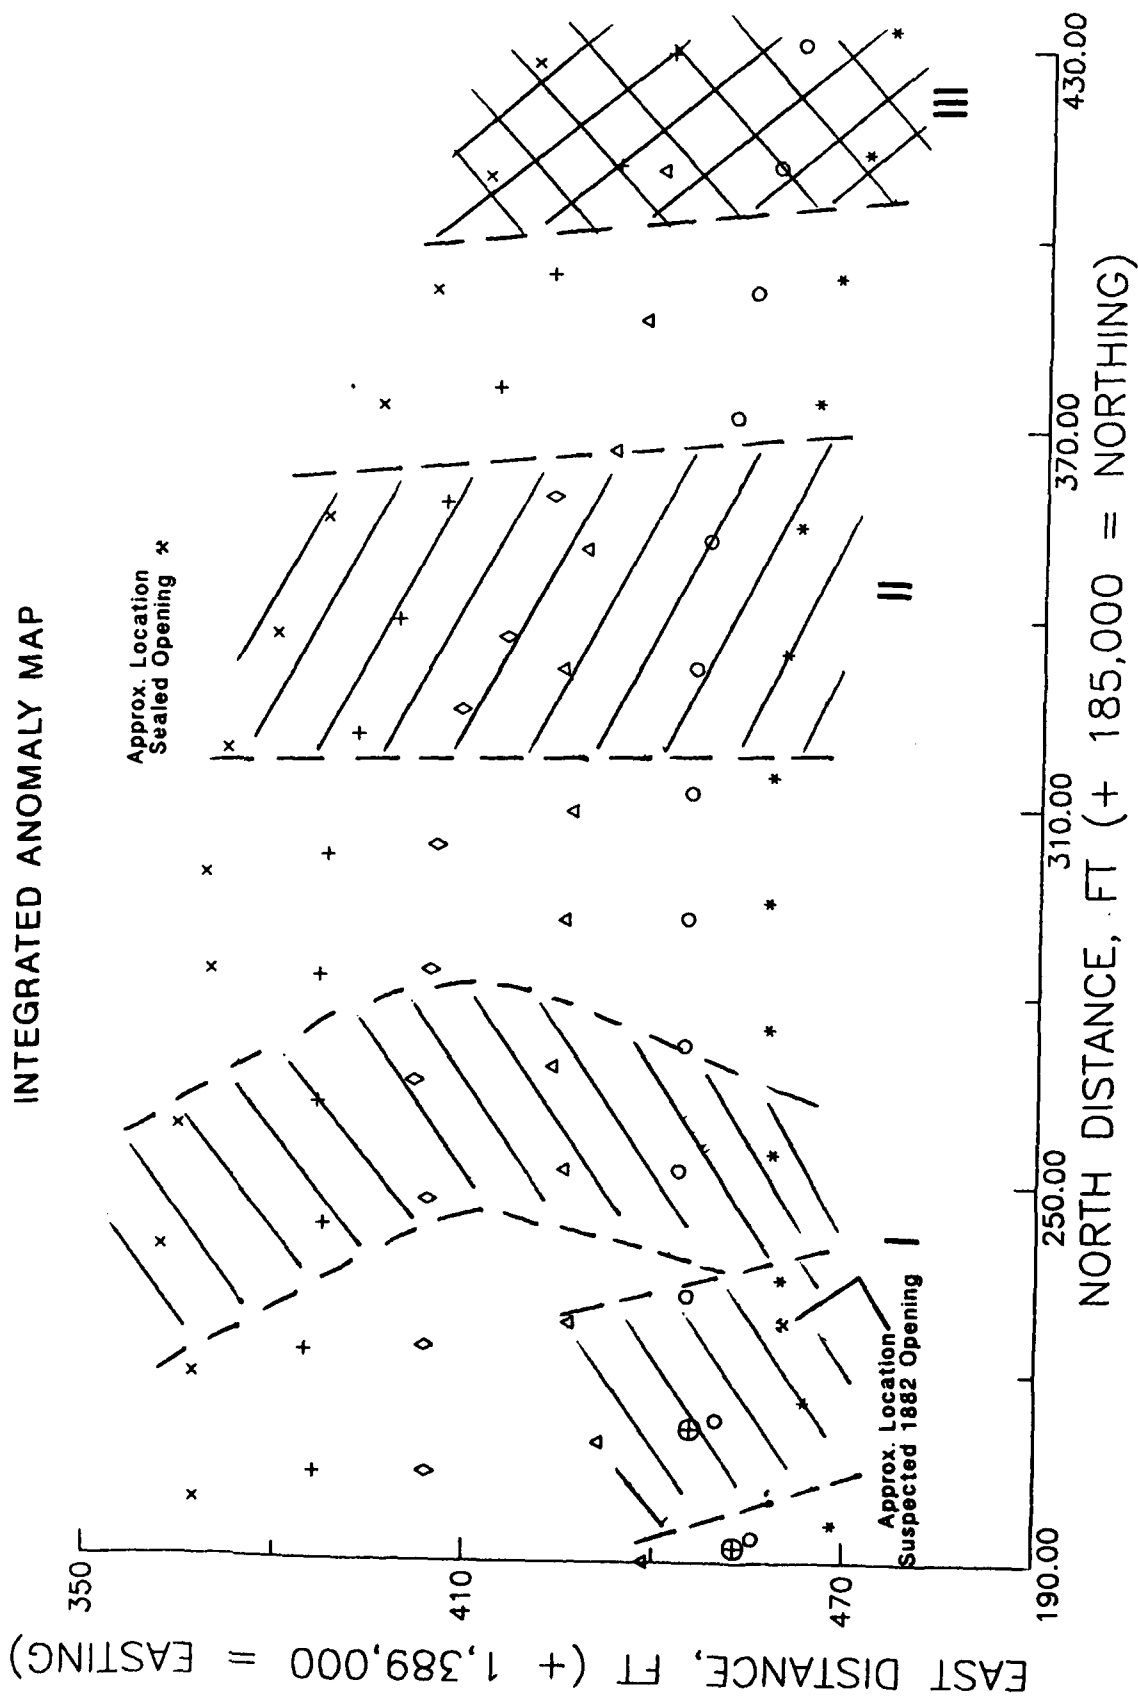
11. Figure 13 is an integrated anomaly map. The three anomaly areas indicated represent an integration of the results of the magnetic and electromagnetic results. The anomalies are defined by magnetic and electromagnetic highs; thus the anomalies are caused by subsurface features which contain metallic debris or structures and material that is otherwise electrically conductive. Anomaly area I is located appropriately to be associated with the suspected 1882 opening, which is indicated on the figure. Anomaly I has a complex structure but may just indicate a large, former opening into the slope which narrowed to a smaller adit accessing the interior of the mine. Anomaly I also correlates with a structure passing under the lower road, which can be observed exposed on the riverward side of the lower road. The structure could be the remnant of a conveyor or support system associated with a mine opening.

Figure 13. Integrated anomaly map for a portion of the left abutment area of Grays Landing Lock and Dam Site

12. Anomaly II may be associated with structures passing through the slope and connecting with the sealed opening in some manner. There is a concrete-lined, steel grate-covered drainage tunnel emerging from the slope and passing under the lower road approximately at location 185,330 N. This drainage tunnel contributes to the overall anomaly and may have been associated with the sealed opening. The appearance of the slope face in the vicinity of and between anomalies I and II indicates the possibility that a substantial portion of the exposed Pittsburgh Coal seam may have been removed to form a large opening into the mine at one time.

end of all the geophysical survey lines was anomalous. There is a well-defined magnetic anomaly maximum on lines I, II, and V at profile location 200-210 ft, while the electromagnetic conductivity increases steadily from profile location 200 ft to the end of the survey lines. There is no known surface or subsurface feature to correlate with this anomalous area.

14. Results of the geophysical surveys in the left abutment area of Grays Landing Lock and Dam Site are less than completely satisfying due to the complexity of the site in terms of surface topography and surface metallic, cultural debris. The surveys succeed, however, in mapping anomalous areas (Figure 13) at the site. Two of the anomalous areas (I and II) trend westward from the lower road area into the slope. One of these anomalous areas (I) may be caused by the suspected 1882 mine opening and its debris fill. If the anomalous areas are investigated by exploratory drilling, the drilling should begin along the centerlines of the areas and then successively offset by approximately 10 ft to each side of the initial borehole, if the initial borehole fails to encounter an anomalous feature. The features causing the anomalies are likely less than 25 ft in depth. However, conservatively, boreholes should be extended to approximately 50 ft depth. Alternatively to drilling, trenching would be an effective technique for investigating anomalous area I for the suspected 1882 mine opening. The trench should be located approximately along survey line II (along the west side of the lower road), beginning about 10 ft north of MS-23 and continuing north for approximately 70 ft or until evidence of an opening is encountered.
